The Temperature/Pressure Relief Valve

Common Violations in the Field

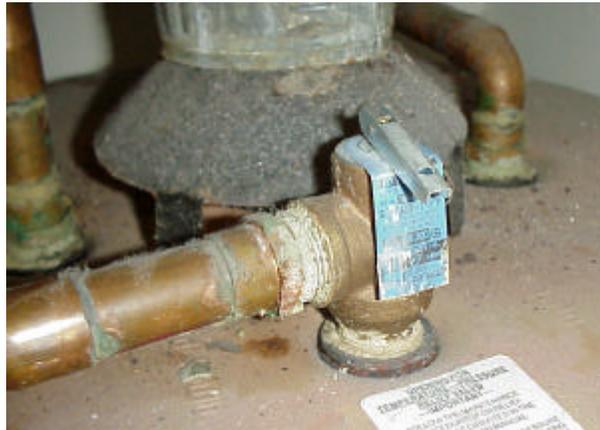
FIGURE 1: Typical installation of a Temperature/Pressure Relief (TPR) Valve on a Water Heater

Figure 1 (right) shows a TPR Valve installed on a gas water heater.

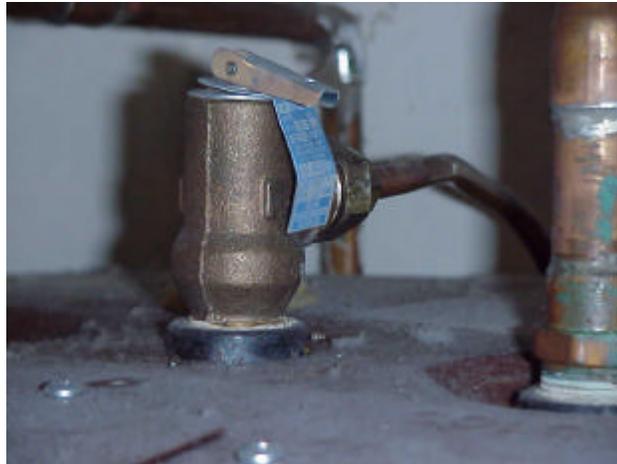
Code Section 3303.6.1.⁴ requires that the TPR valve is fitted with a discharge pipe that provides the **same size opening as the valve outlet itself**.

Figure 2 (right) shows a TPR Valve that has been fitted with a discharge pipe that is **smaller** than the size of the valve outlet. This is a common defect that is strictly prohibited because smaller discharge pipes restrict the flow of the pressurized water released by the valve. This creates a dangerous bottleneck, building-up even more pressure at the point of discharge that can cause the tank to explode. Personal injury (or death) and property damage may result

Figure 2: Improperly-sized TPR Valve Discharge Pipe

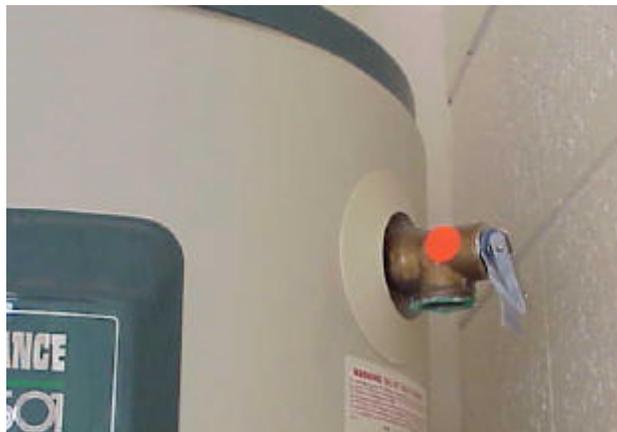
In many instances, the discharge pipe required in Section 3303.6.1.⁵ was never installed at all. This normally occurs during replacement or initial installation of the water heater.

Figure 3 (right), shows a missing TPR discharge pipe. This creates a dangerous condition whereby the TPR valve will spray scalding steam or scalding hot water onto anyone (or anything) that happens to be near the water heater when discharge occurs.

FIGURE 3: Missing TPR Valve Discharge Pipe

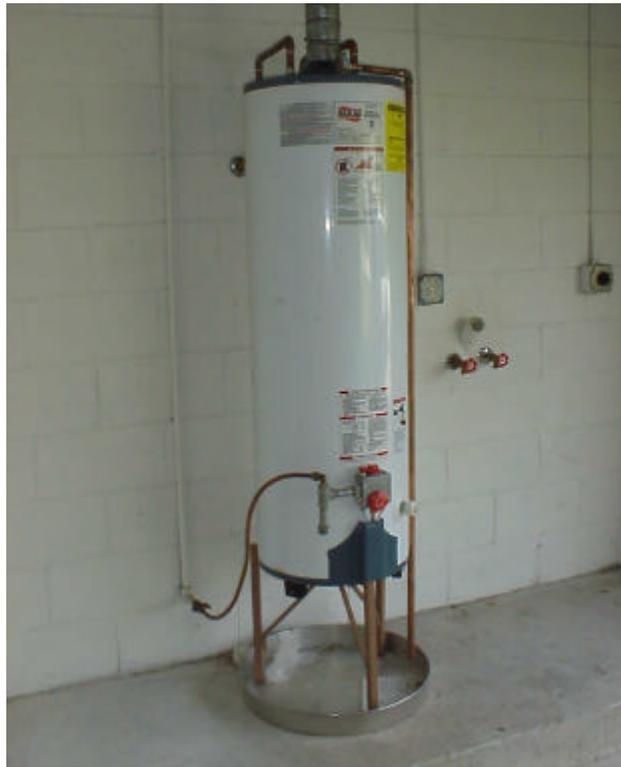
This is clearly not the case in Figure 4 (right). Here we see the copper discharge pipe runs down the right hand side of the water heater tank to terminate into a metal spill pan below. However, the problem lies in the fact that the end of this discharge pipe terminates below the upper rim of a shallow spill pan.

First, the discharge pipe may be able to siphon any liquid that may accumulate inside the pan. This is due to the fact that the end of the discharge pipe terminates below the top rim of the receptacle itself. Once siphoning occurs, the liquid (be it dirty water, household chemicals, oil, etc.) will be drawn back into the water heater tank, thereby contaminating the household drinking water supply.

FIGURE 4: Improper termination of Discharge Pipe

While this occurrence is admittedly unlikely due to the fact that the TPR valve would have to fail (stay open) while a simultaneous drop in line pressure would create a siphon, the mechanical potential does exist for this contamination to occur. Thus the air gap provision in the building code.

Secondly, and even more likely, is the risk of personal injury when this TPR valve discharges. This is because the discharge pipe terminates into a spill pan that cannot safely catch the flow of water or steam during discharge. When you consider that the TPR valve discharges at 150 psi, which is five times greater than the force of your garden hose, the scalding water can strike the bottom of the shallow pan and spray out in all directions. Therefore, a deeper receptacle with adequate circumference would be advisable over the shallower, tightly-fitting spill pans commonly observed in the field.
