common code violations

Mortar Joints

One of the more common code violations our inspectors observe in the field involves the thickness and workmanship of mortar joints in masonry construction. The purpose of this article is to assist property owners and construction and inspection professionals in identifying these common code violations so they may be corrected.

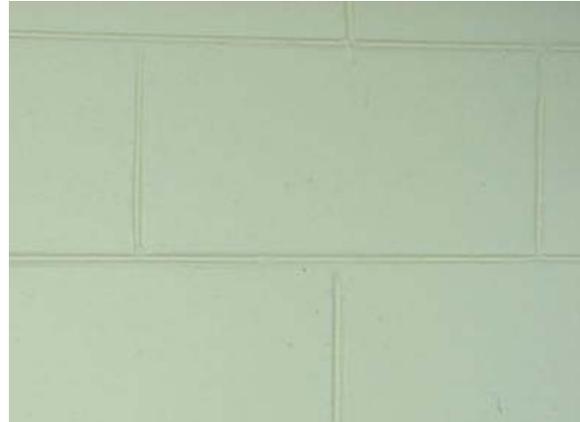
Figure 1: Properly-sized and tooled mortar joints in a masonry wall.

Figure 1 shows a masonry wall on a residential property with exposed mortar joints. Notice how the joints have been properly-sized and the mortar tooled for a smooth, professional-looking job. The tooling operation helps to compact the mortar, providing protection against water penetration in areas subjected to heavy rains and winds.

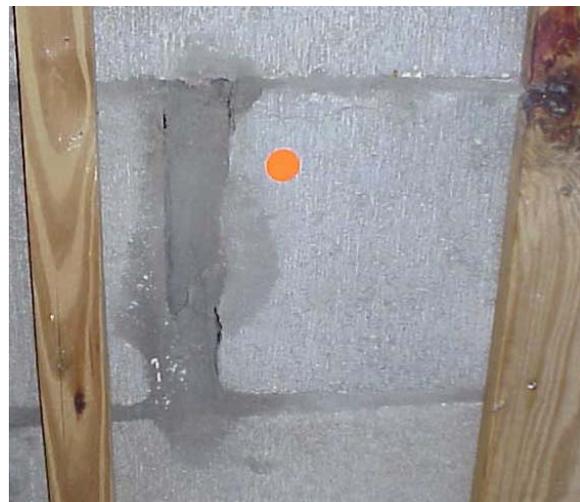
Figure 2 shows the inside view of a poorly laid mortar header joint that well exceeds the allowable 3/8" width limit established by code. In fact, this vertical header joint measured more than 1" wide. As a result, the mortar will dry and shrink, leaving gaps which will allow water and cold air to penetrate through the wall.

Unfortunately, mortar joint defects such as this are becoming increasingly common in today's residential construction and often go undetected by the new home owner.

FIGURE 2: Improper mortar joint thickness.

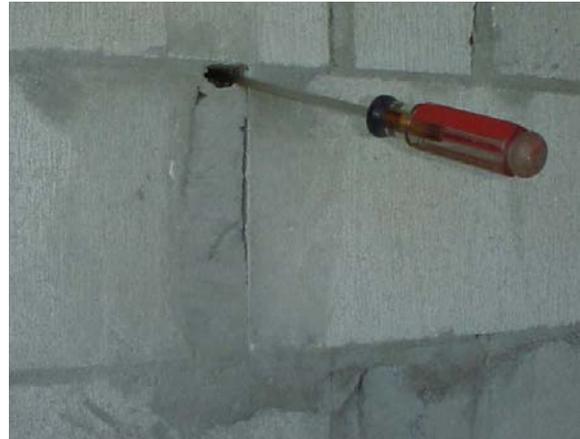
Figure 3 shows an outside view of another poorly laid header joint that well exceeds the allowable 3/8" width limit established by code.

This header joint not only measured nearly 2" in width, it also had open gaps in the mortar, allowing visible daylight (and our Inspector's screwdriver) to easily penetrate through the mortar joint. As a result, water and moisture will be able to penetrate through this wall, which is a common cause of water and wood destroying insect damage in the near future as the stucco cladding (siding) begins to crack.

FIGURE 3: Improper mortar joint thickness with large gaps due to shrinkage of mortar between the concrete blocks.

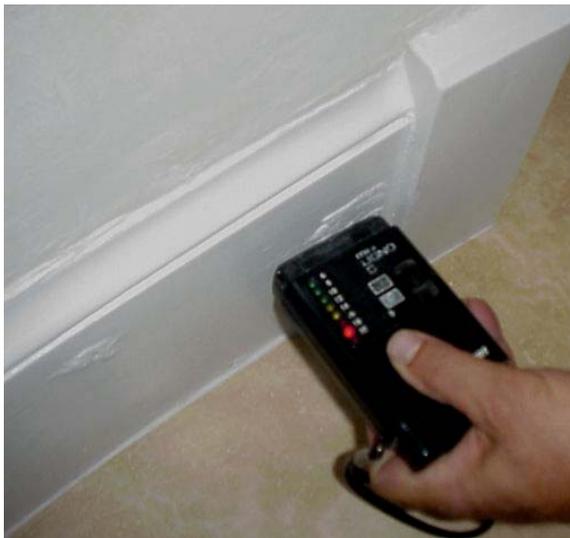
Figures 4 and 5 below show the end result of improper mortar joints – water penetration into a very expensive custom-built home shortly after the new owner takes occupancy. This damage could have been avoided by proper mortar joint sizing and by tooling the mortar between the joints.

FIGURE 4: "Bubbled paint" and moisture meter readings indicate high levels of moisture in a wall due to water seepage through improperly-sized mortar joints.

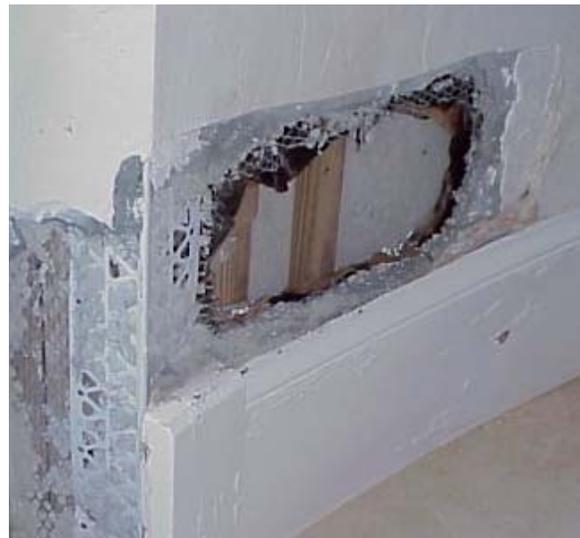
FIGURE 5: Removal of the plaster wall surface reveals water damaged elements that could have been avoided by properly-sizing and tooling mortar joints.
